PHOTOGRAPHIC INTERPRETATION REPORT

~~TOP SECRET~~  
**SOUTHEAST ASIA  
ACTIVITY REPORT**

**SELECTED TRANSPORTATION  
AND INFILTRATION  
COMPENDIUM  
22-28 SEPTEMBER 1966**

NPIC/R-344/66  
SEPTEMBER 1966

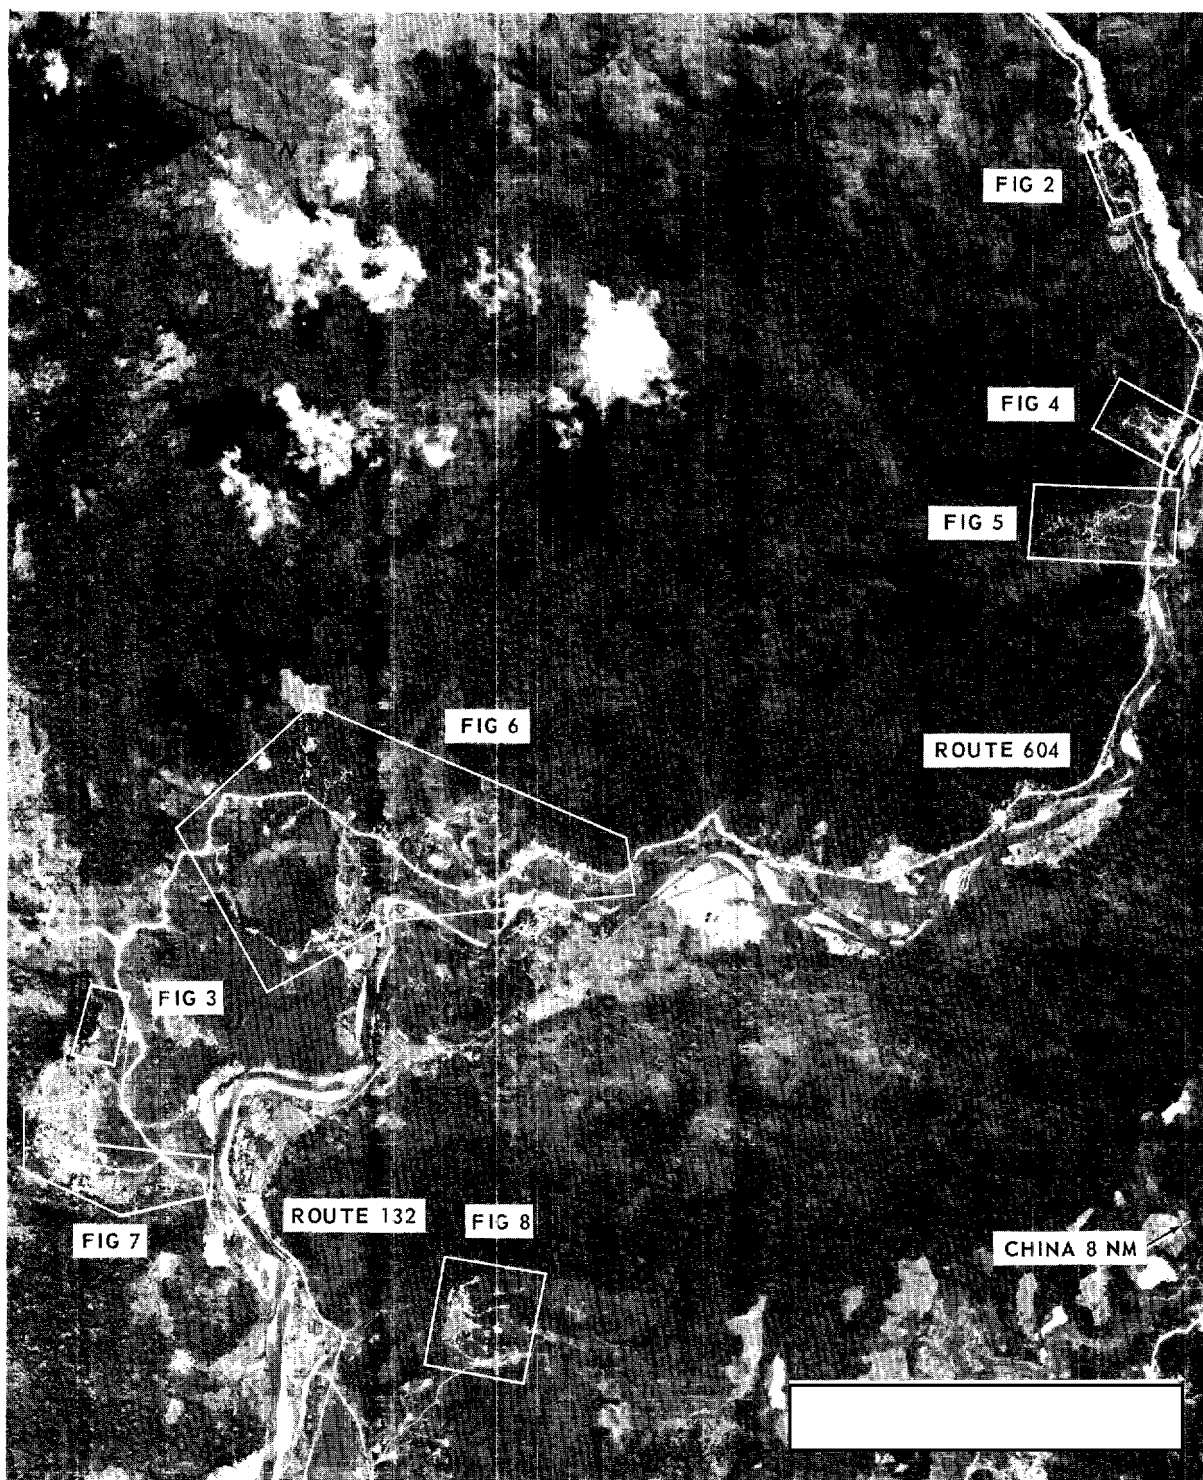
NPIC L-564 (9/66)

Eight storage facilities/military camps have been observed along Routes 604 and 132 in the Phong Tho area of North Vietnam, approximately 8 nm from the China border (Figure 1). These facilities are in addition to the 20 facilities, predominately storage, previously identified by NPIC on Route 6 between Lai Chau and the China border and south of Lai Chau on Routes 4, 6, and 191 (Summary 19, Item 1). The new areas, located from 20-32N 103-16E to 22-31N 103-21E, contain a total of at least 146 dispersed buildings; three areas contain vehicle parking slots.

FIGURE 1. PROBABLE MILITARY FACILITIES, PHONG THO AREA, NORTH VIETNAM.

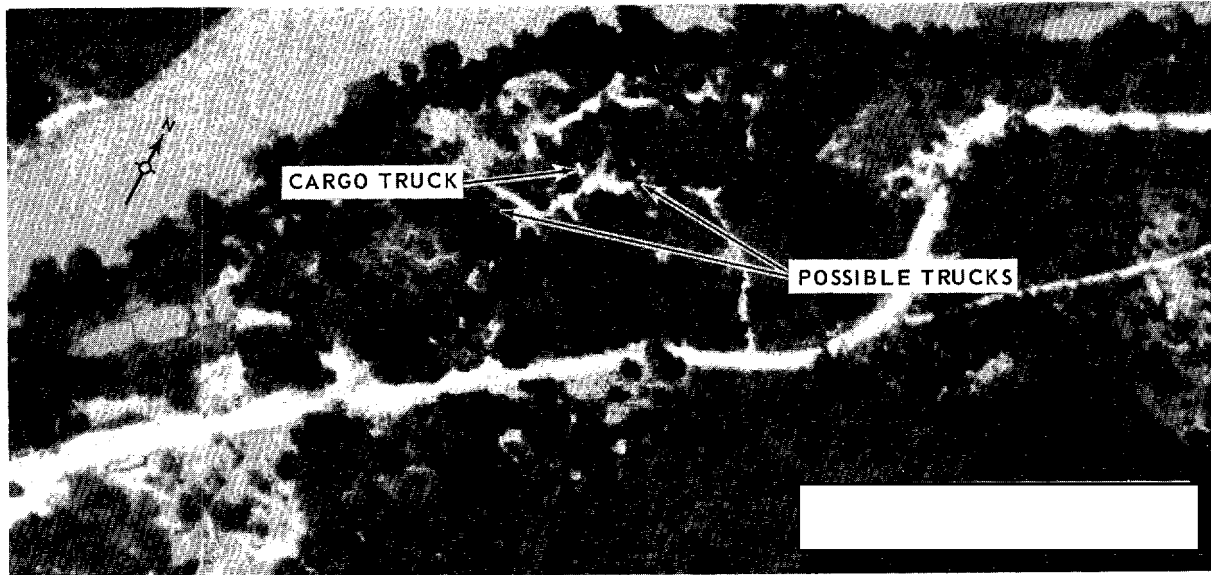
NPIC L-5565 (9/66)

A truck park 4.4 nm west of Phong Tho at 20-32N 103-17E (UTM UK236930) contains one cargo truck, two possible trucks, and several vehicle parking slots (Figure 2). Two trucks are observed on Route 604 traveling in opposite directions, 1.6 nm south of the truck park at 20-30N 103-16E (UTM UK224902).

FIGURE 2. TRUCK PARK, ROUTE 604, NORTH VIETNAM.

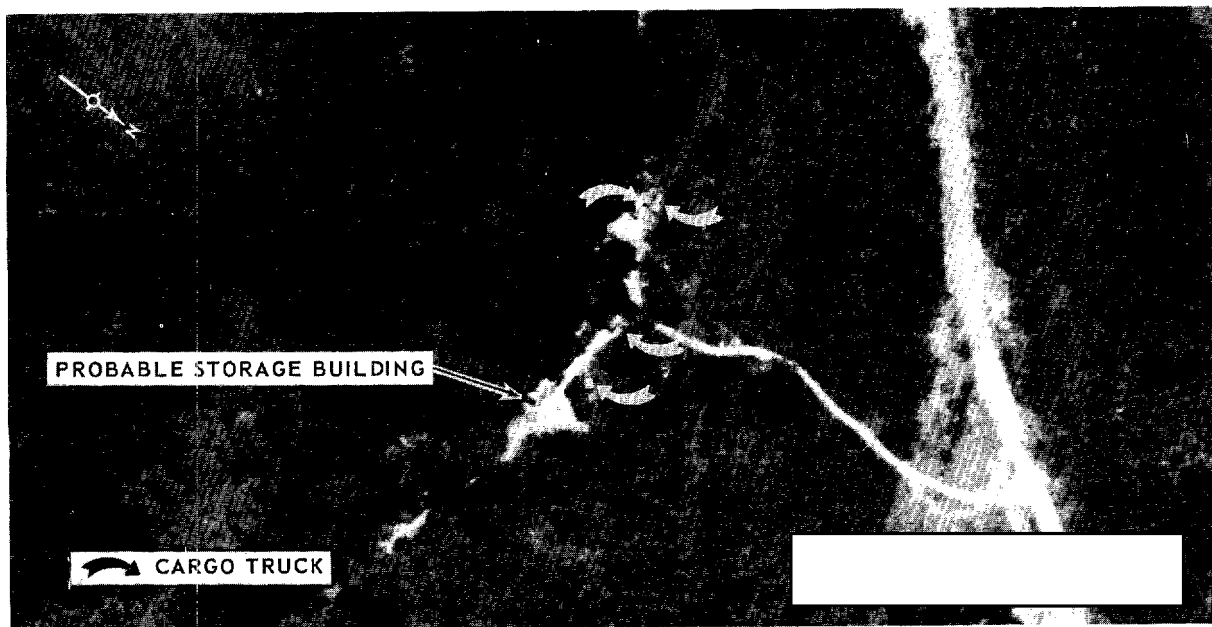
NPIC L-5566 (9/66)

A truck park and probable storage area 1.4 nm southwest of Phong Tho at 22-30N 103-20E (UTM UK299901) contains at least one probable storage building and four cargo trucks (Figure 3).

FIGURE 3. TRUCK PARK AND PROBABLE STORAGE AREA, ROUTE 132, NORTH VIETNAM.

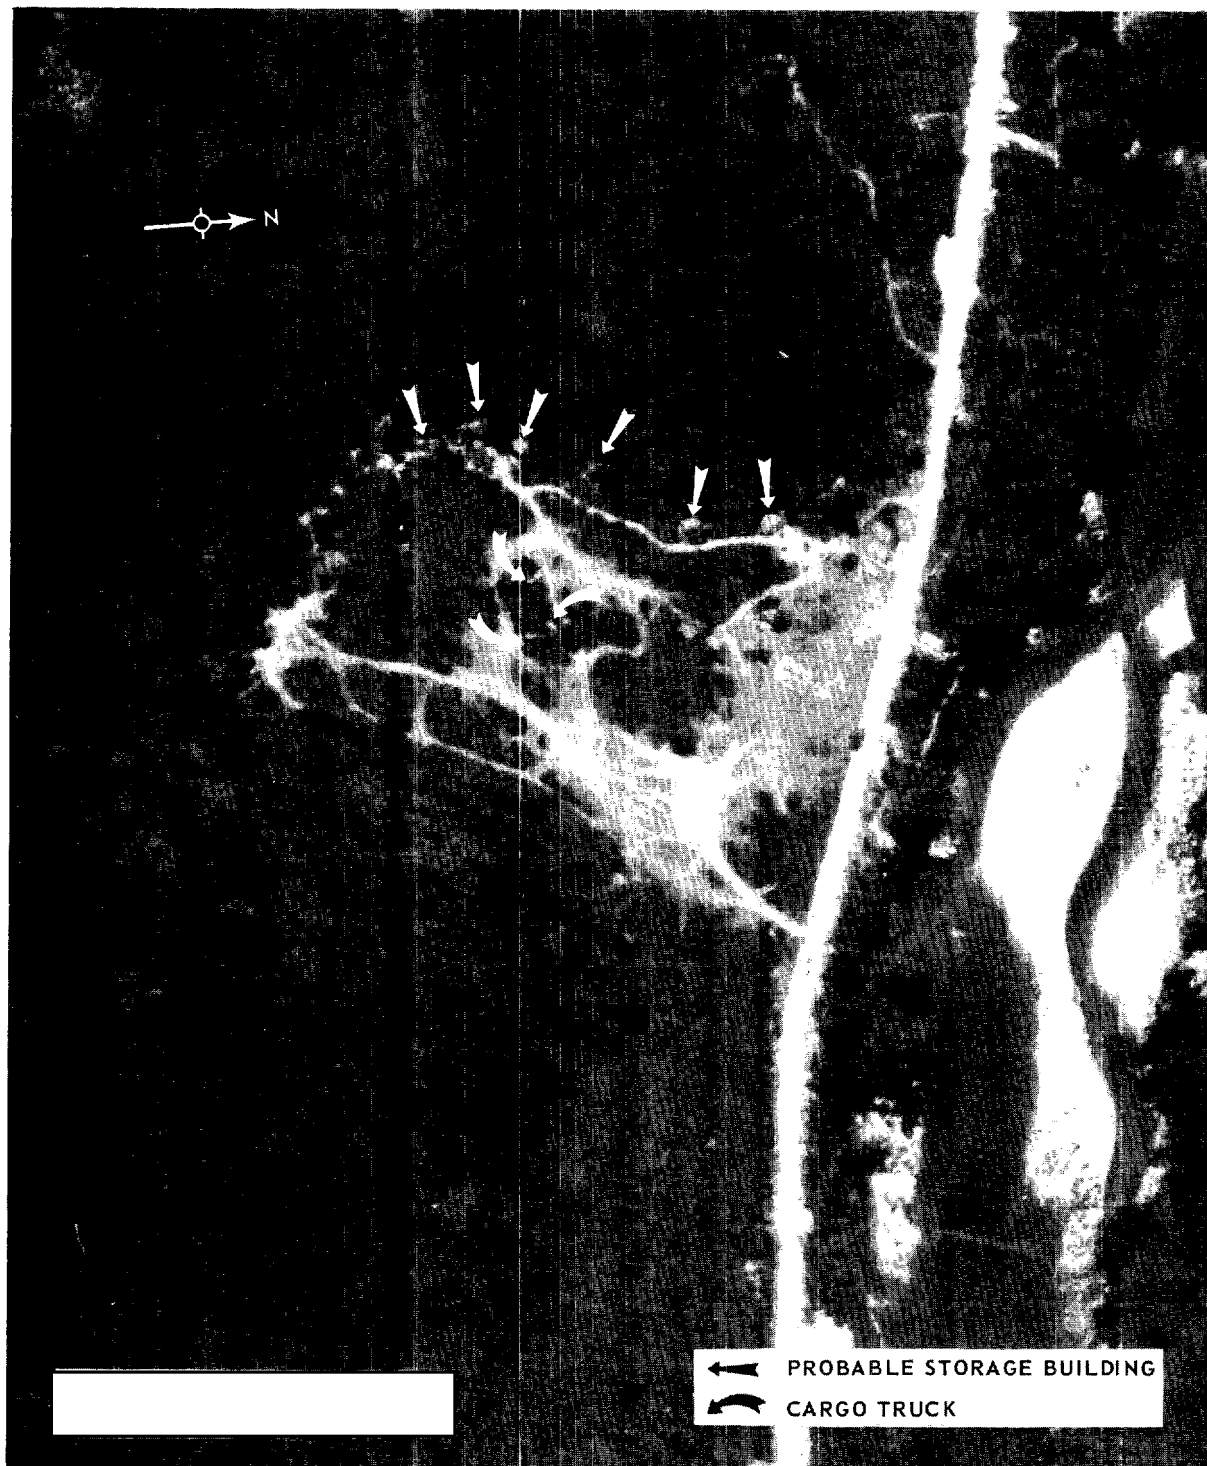
NPIC L 5567 (9/66)

A truck park and probable storage area 3.8 nm west-northwest of Phong Tho at 20-32N 103-17E (UTM UK248935) contains at least six dispersed, probable storage buildings, three cargo trucks, and numerous vehicle parking slots (Figure 4).

FIGURE 4. TRUCK PARK AND PROBABLE STORAGE AREA, ROUTE 604, NORTH VIETNAM.

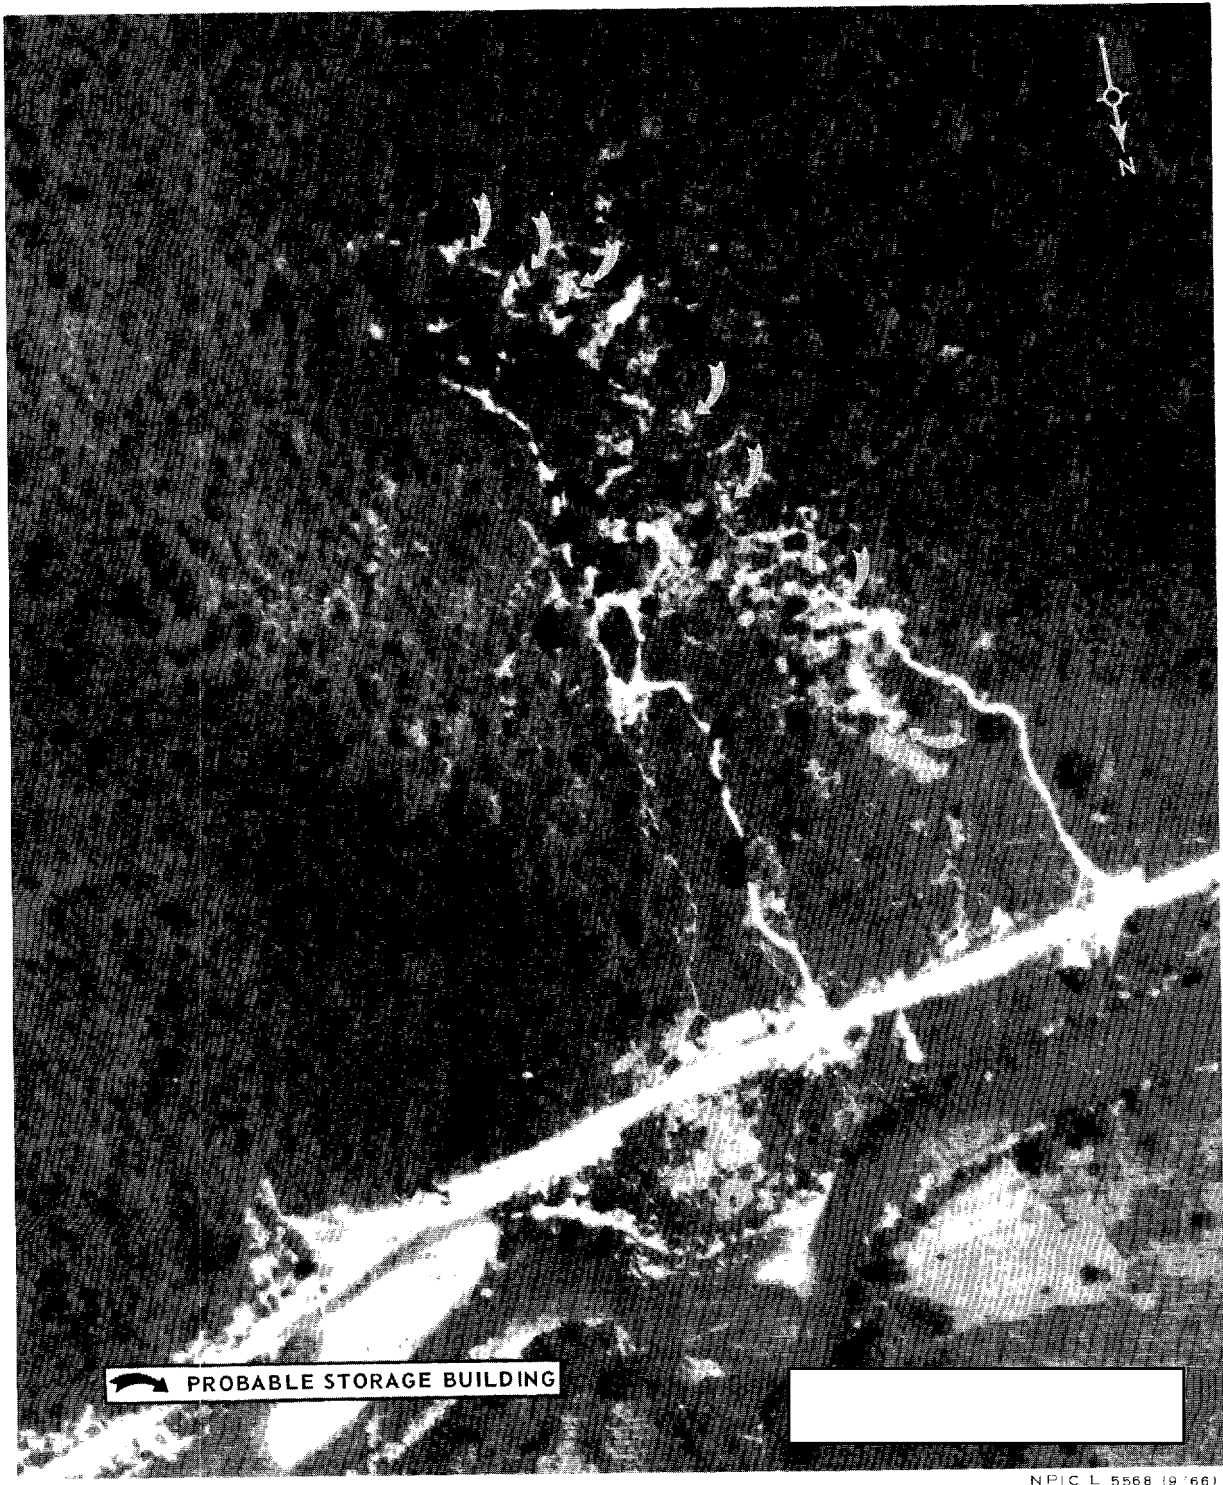
A road-served probable storage area 3.5 nm west-northwest of Phong Tho at 20-32N 103-18E (UTM UK253933) contains at least seven dispersed, probable storage buildings (Figure 5).

FIGURE 5. PROBABLE STORAGE AREA, ROUTE 604, NORTH VIETNAM.

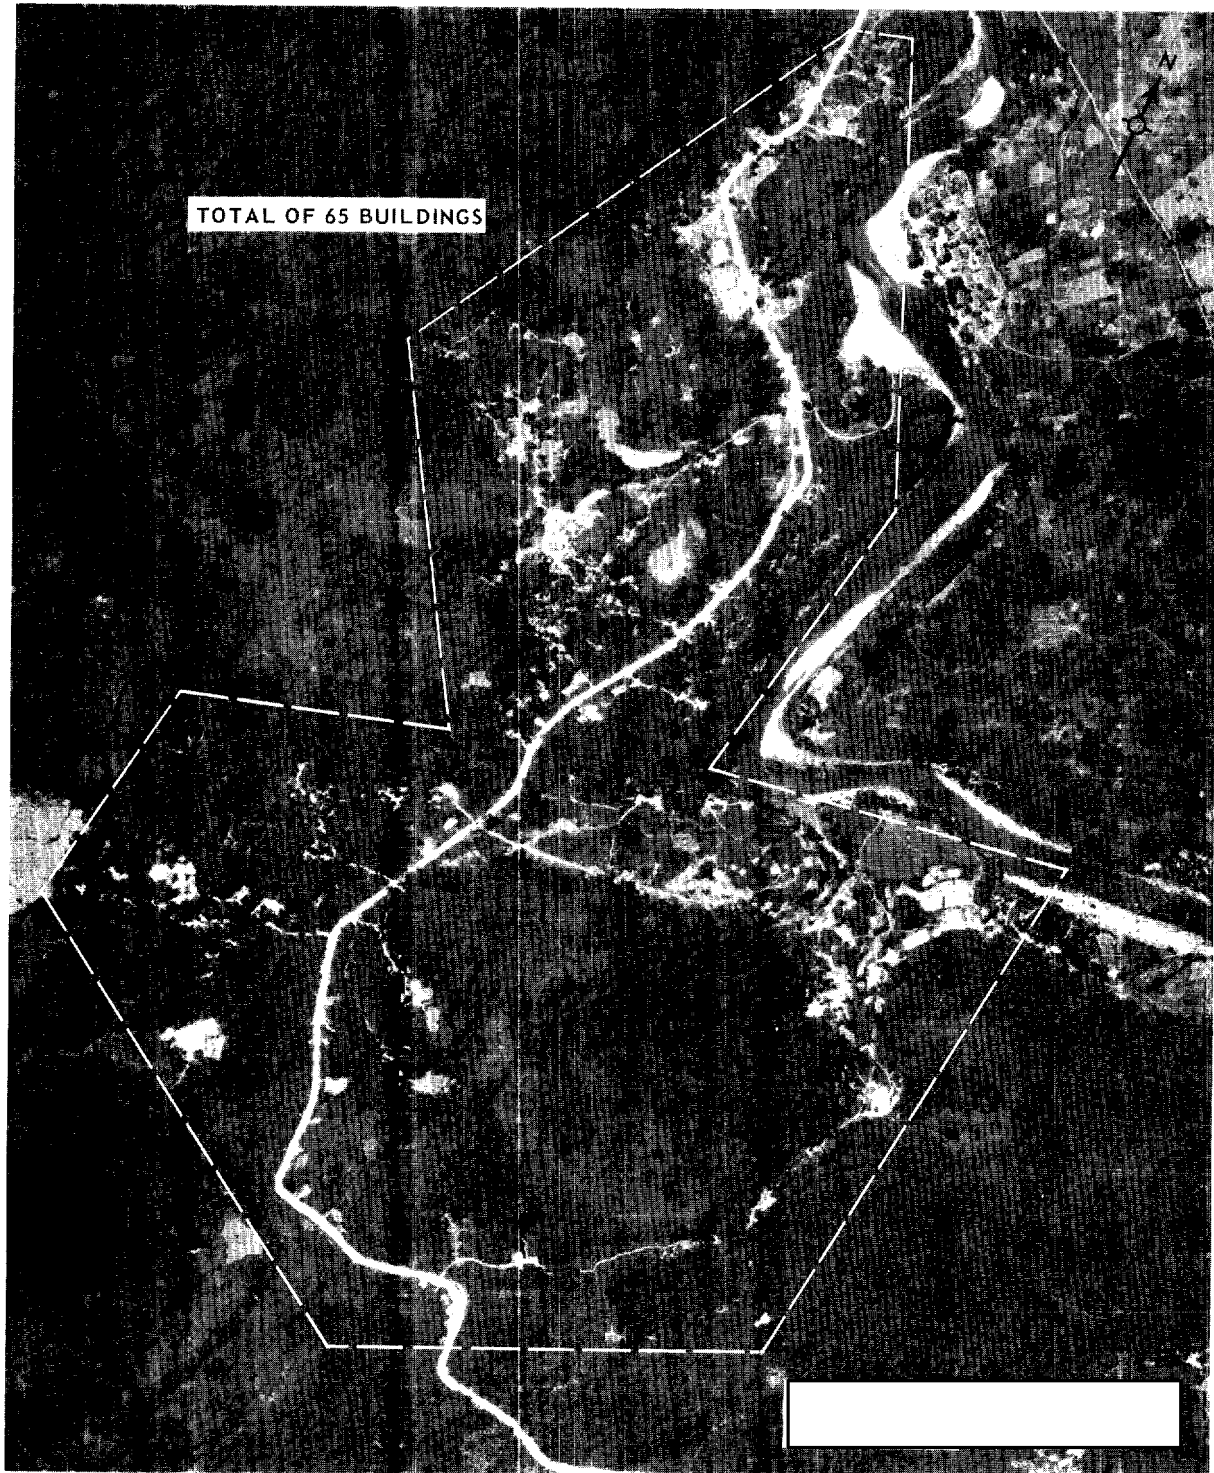
A large, irregularly shaped probable military camp and storage area located on both sides of Route 604 and 1.9 nm west-southwest of Phong Tho at 22-31N 103-20E (UTM UK285907) contains at least 65 dispersed buildings and 15 vehicle parking slots (Figure 6).

FIGURE 6. PROBABLE MILITARY CAMP AND STORAGE AREA COMPLEX,  
ROUTE 604, NORTH VIETNAM.

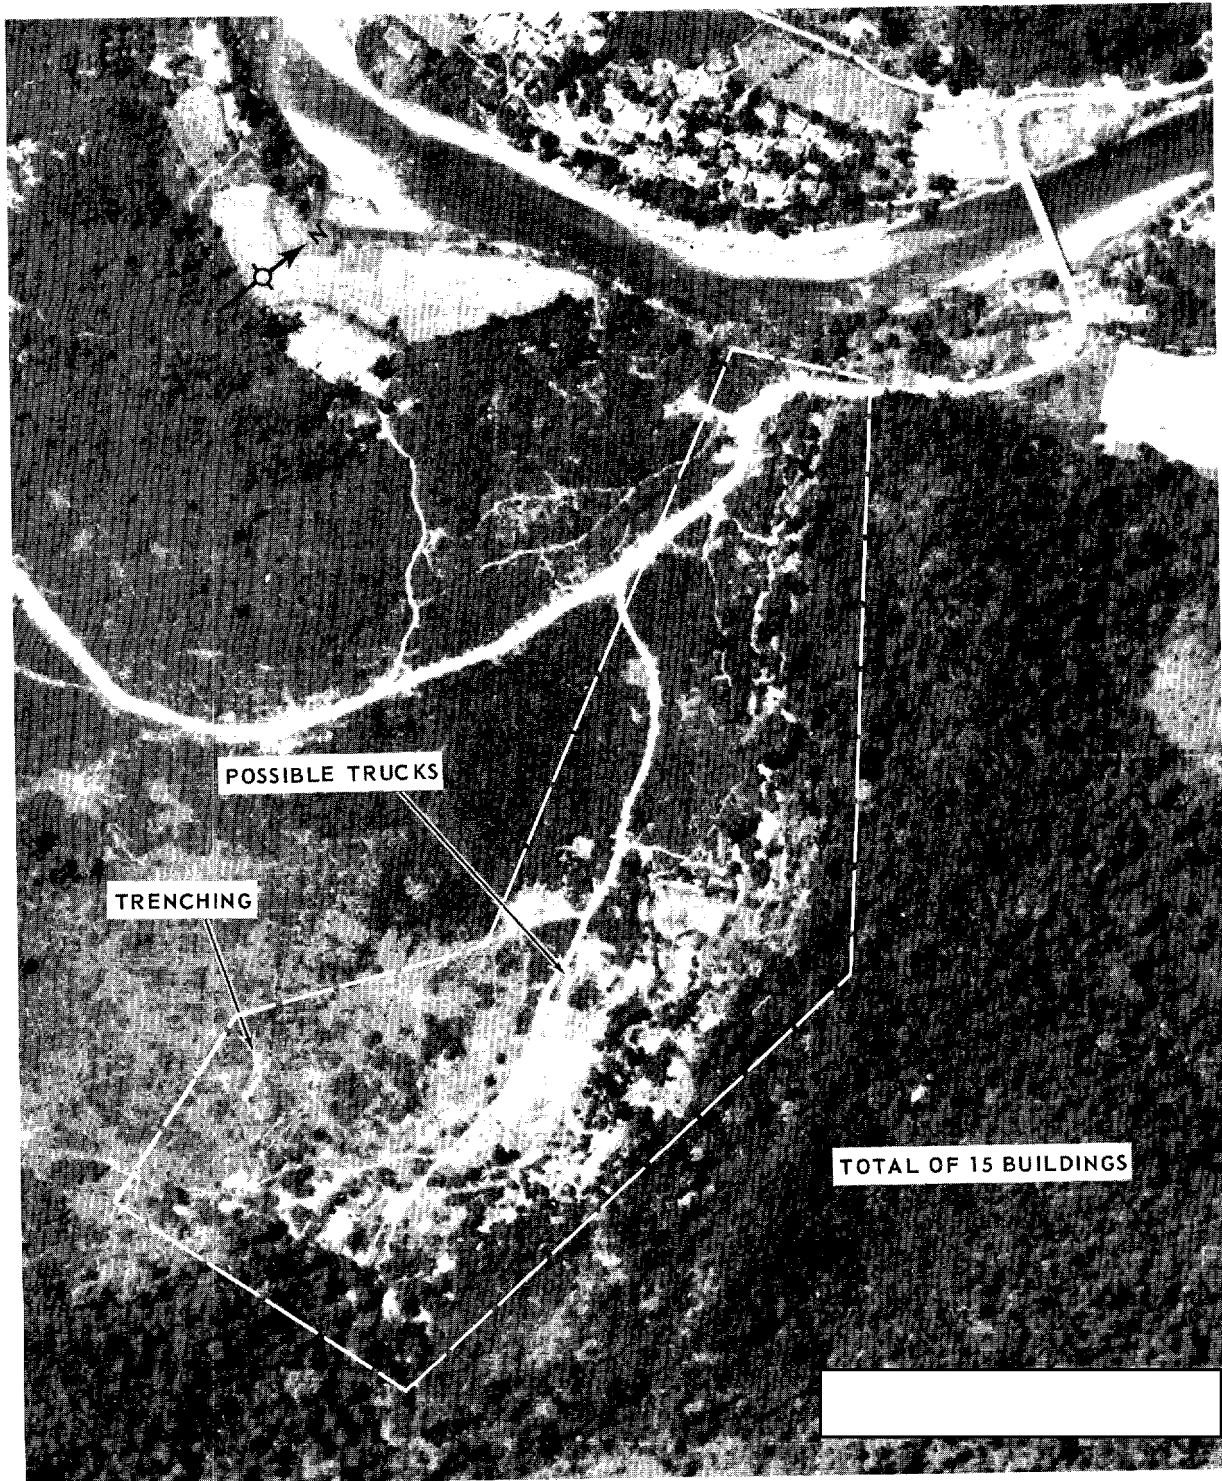
NPIC L 5570 (9/66)

A road-served military camp and probable storage area 1.2 nm southwest of Phong Tho at 22-30N 103-21E (UTM UK304906) contains at least 15 dispersed buildings, two possible trucks, and personnel trenching (Figure 7).

FIGURE 7. MILITARY CAMP AND PROBABLE STORAGE AREA, ROUTE 132, NORTH VIETNAM.

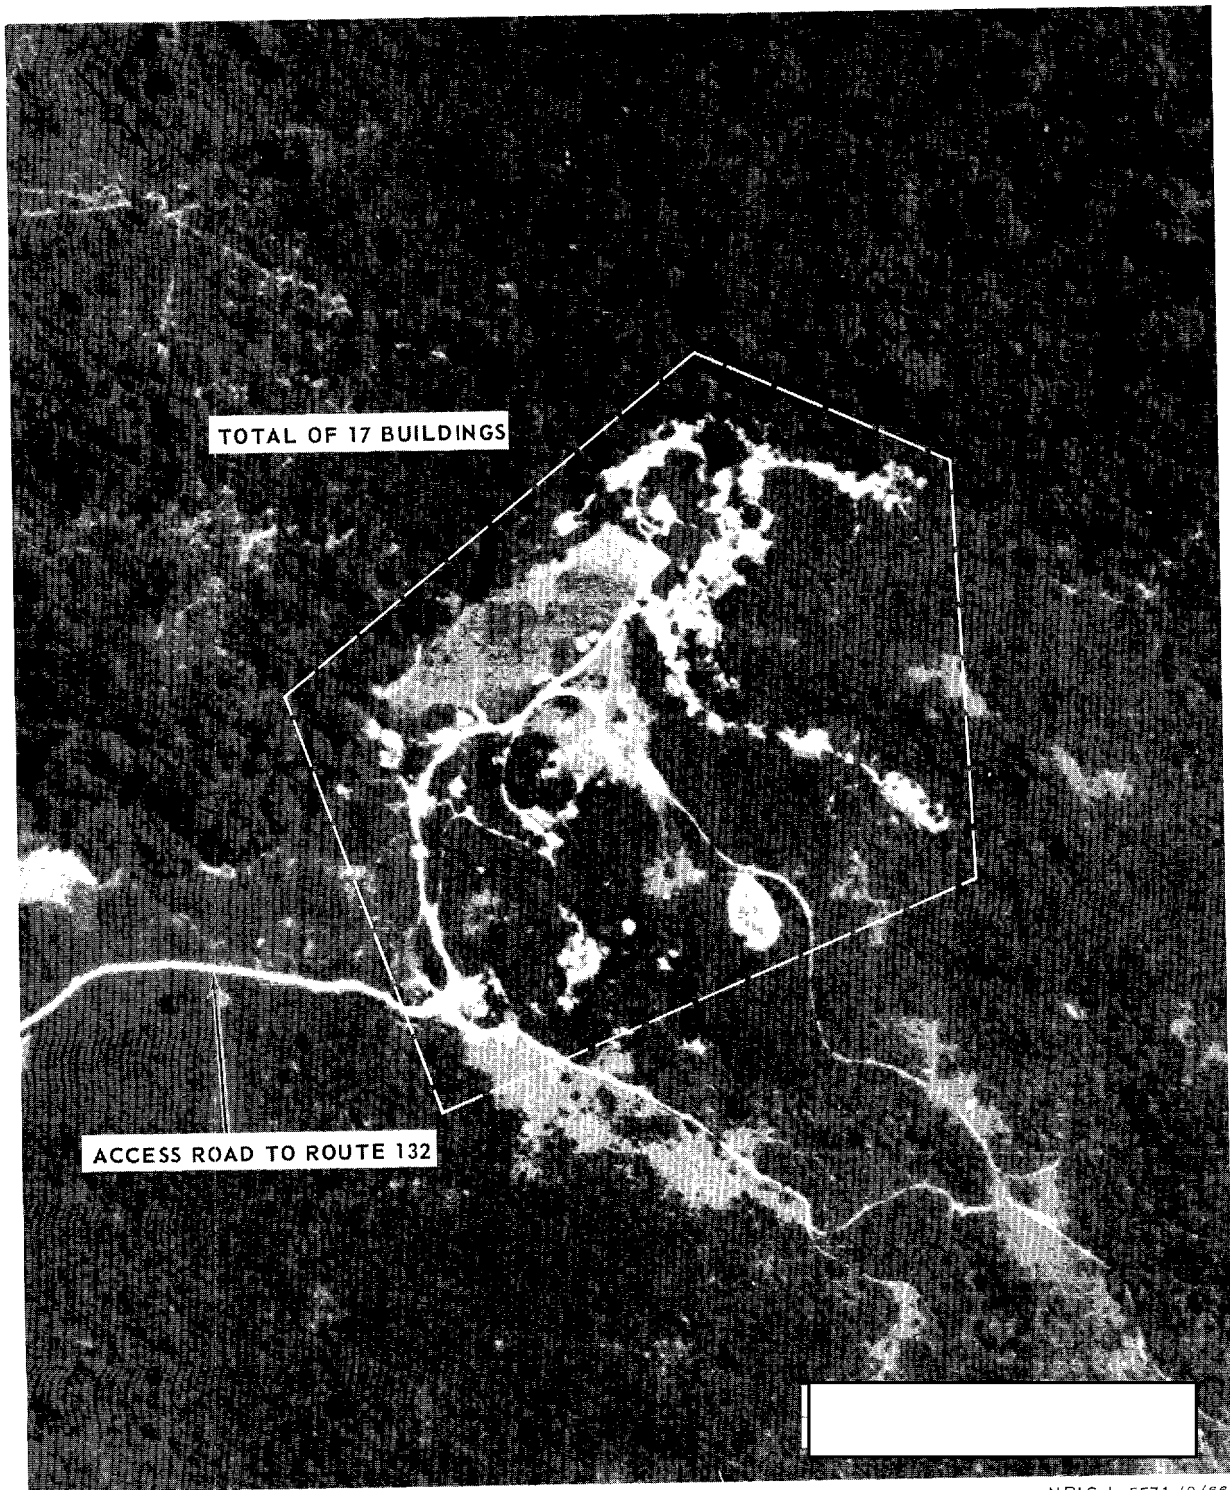
NPIC L-5571 (9/66)

A road-served probable storage area 0.9 nm west of Phong Tho at 22-31N 103-21E (UTM UK302921) contains at least 17 dispersed buildings (Figure 8).

FIGURE 8. PROBABLE STORAGE AREA, ROUTE 132, NORTH VIETNAM.

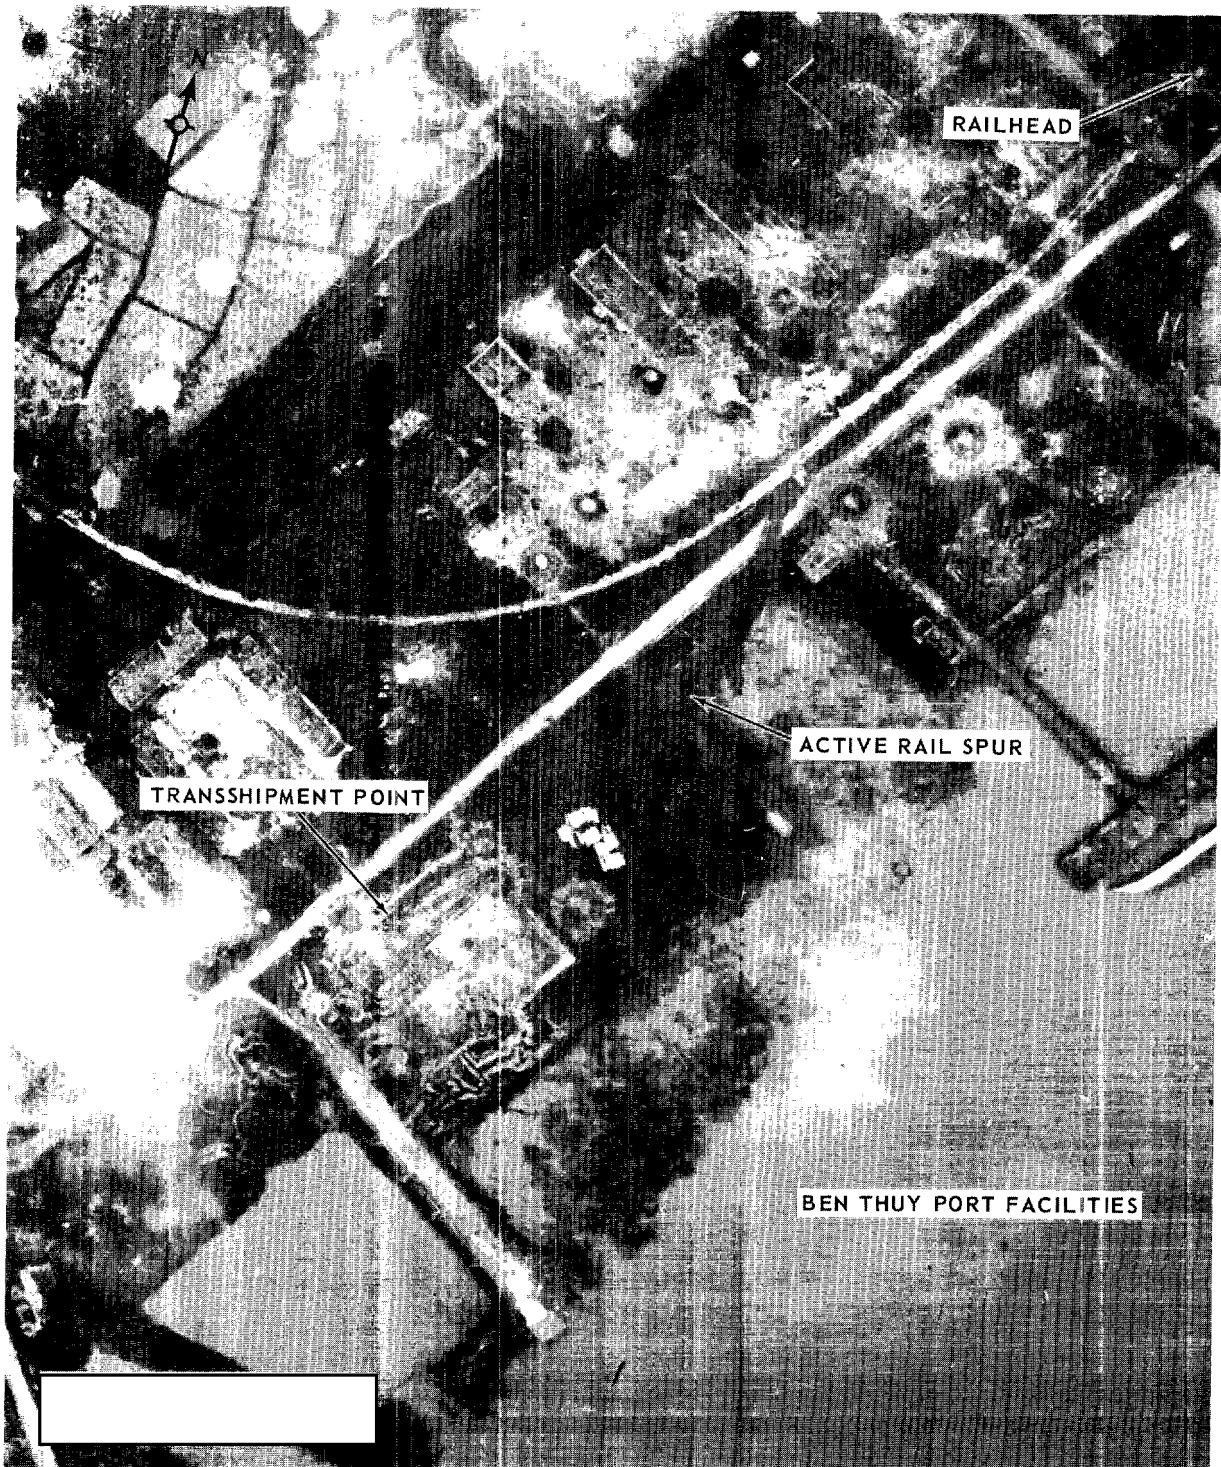
NPIC L 5574 (9/66)

The most significant operational change in the rail line since its status was reported in Summary 15 is the construction of a new transshipment point on the Ngan Sau Giang (river), 900 meters east of the destroyed Xom Hoai Railroad and Highway Bridge over the Rao No [REDACTED] at UTM WF685217, where a rail spur is nearing completion (Figure 12). The construction of a by-pass around the Xom Hoai bridge has been abandoned and the railbed is partially overgrown. There has been no attempt to maintain the rail line north of this point, and the previously reported transshipment point at the destroyed Trai Hoi Railroad Bridge over the Ngan Sau [REDACTED] at UTM WF651299 has been abandoned (Figure 11). Therefore, this new transshipment area is apparently being developed as the northern terminus of the rail line and waterborne transportation will apparently be used between this point and the Ben Thuy port facilities, located 2 nm southeast of Vinh (Figures 9 and 10).

FIGURE 10. RAILROAD TRANSSHIPMENT POINT, VINH AREA, NORTH VIETNAM.

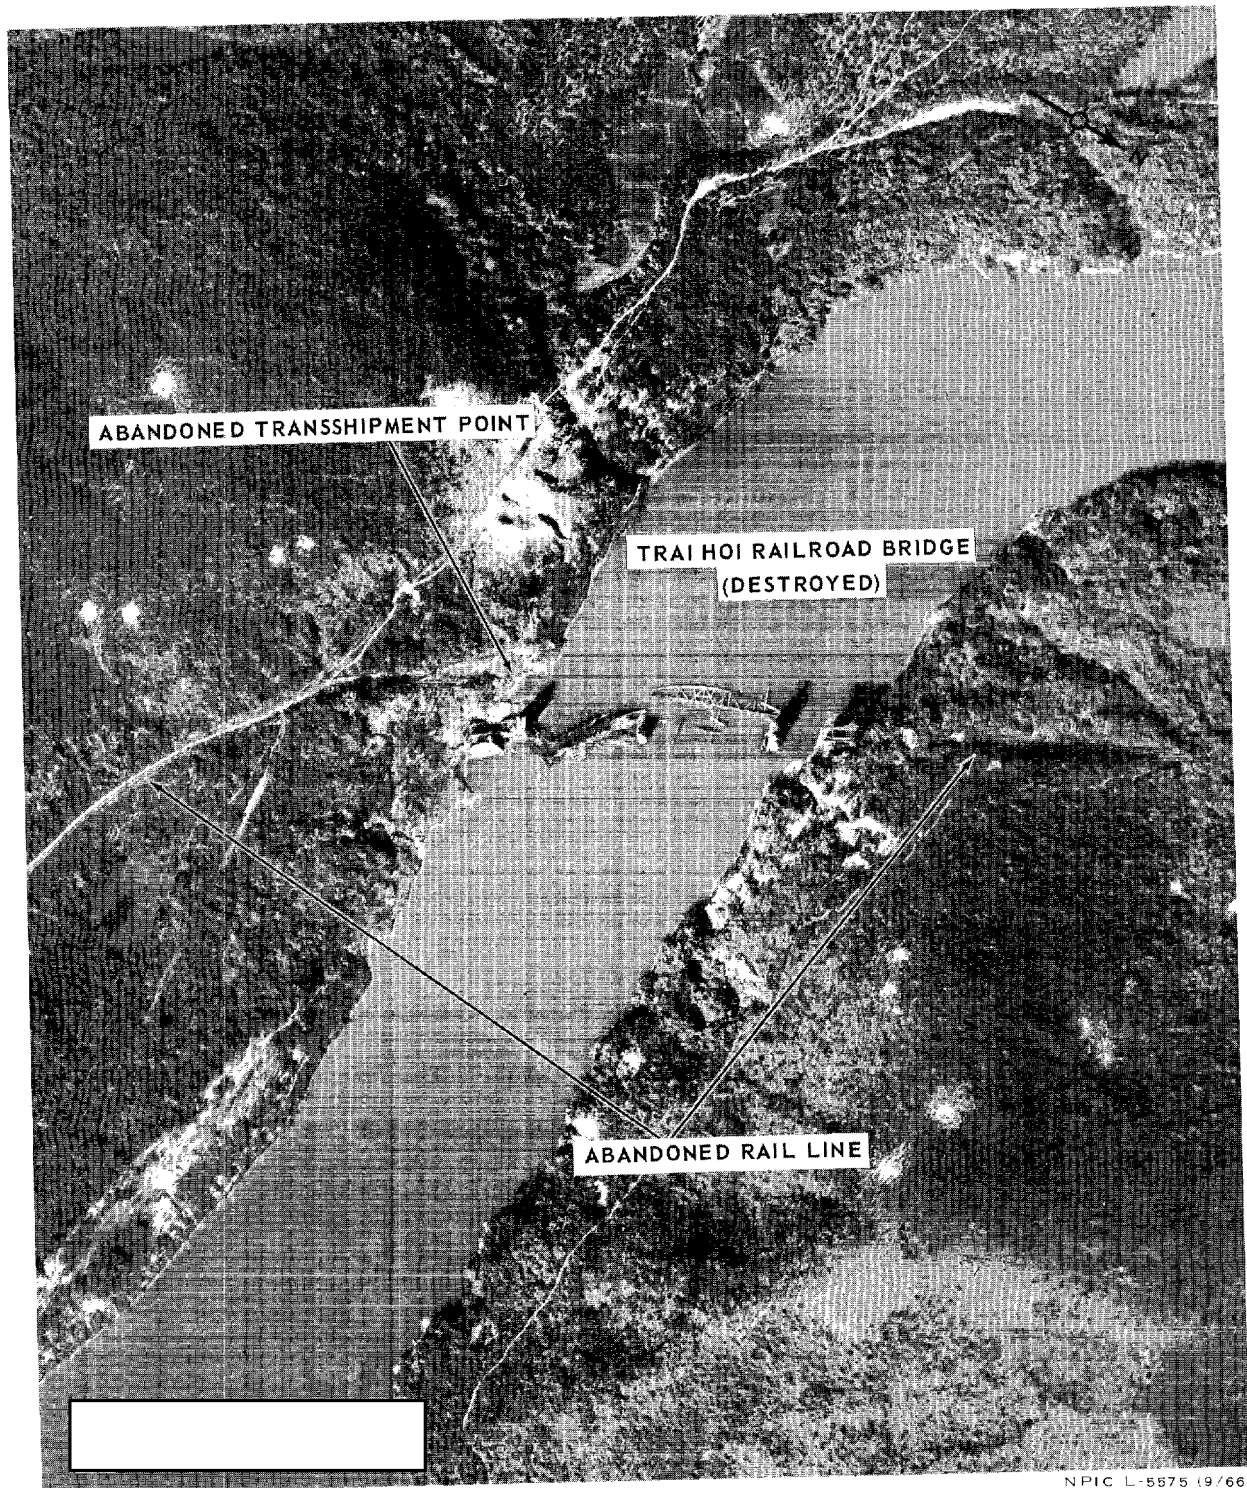
FIGURE 11. ABANDONED RAIL SEGMENTS, VINH/DONG HOI RAIL LINE, NORTH VIETNAM.

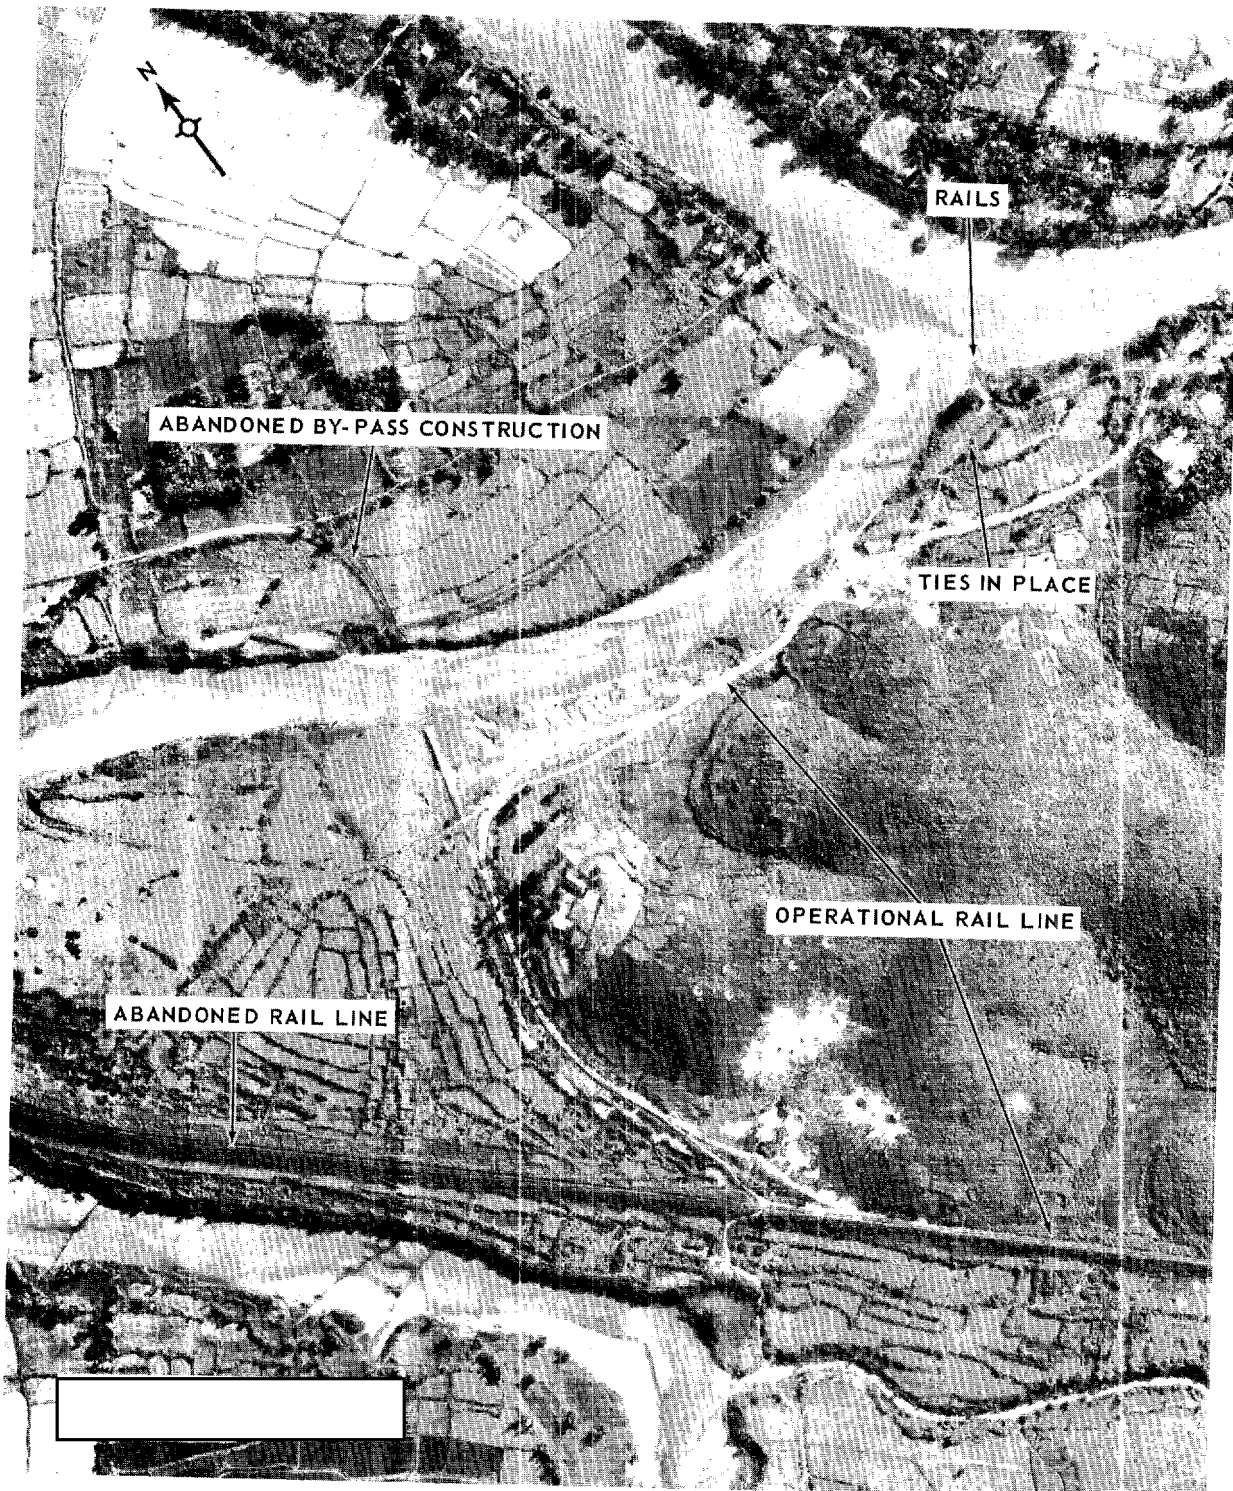
NPIC L 5576 (9 '66)

FIGURE 12. TRANSSHIPMENT POINT, VINH/DONG HOI RAIL LINE, NORTH VIETNAM.

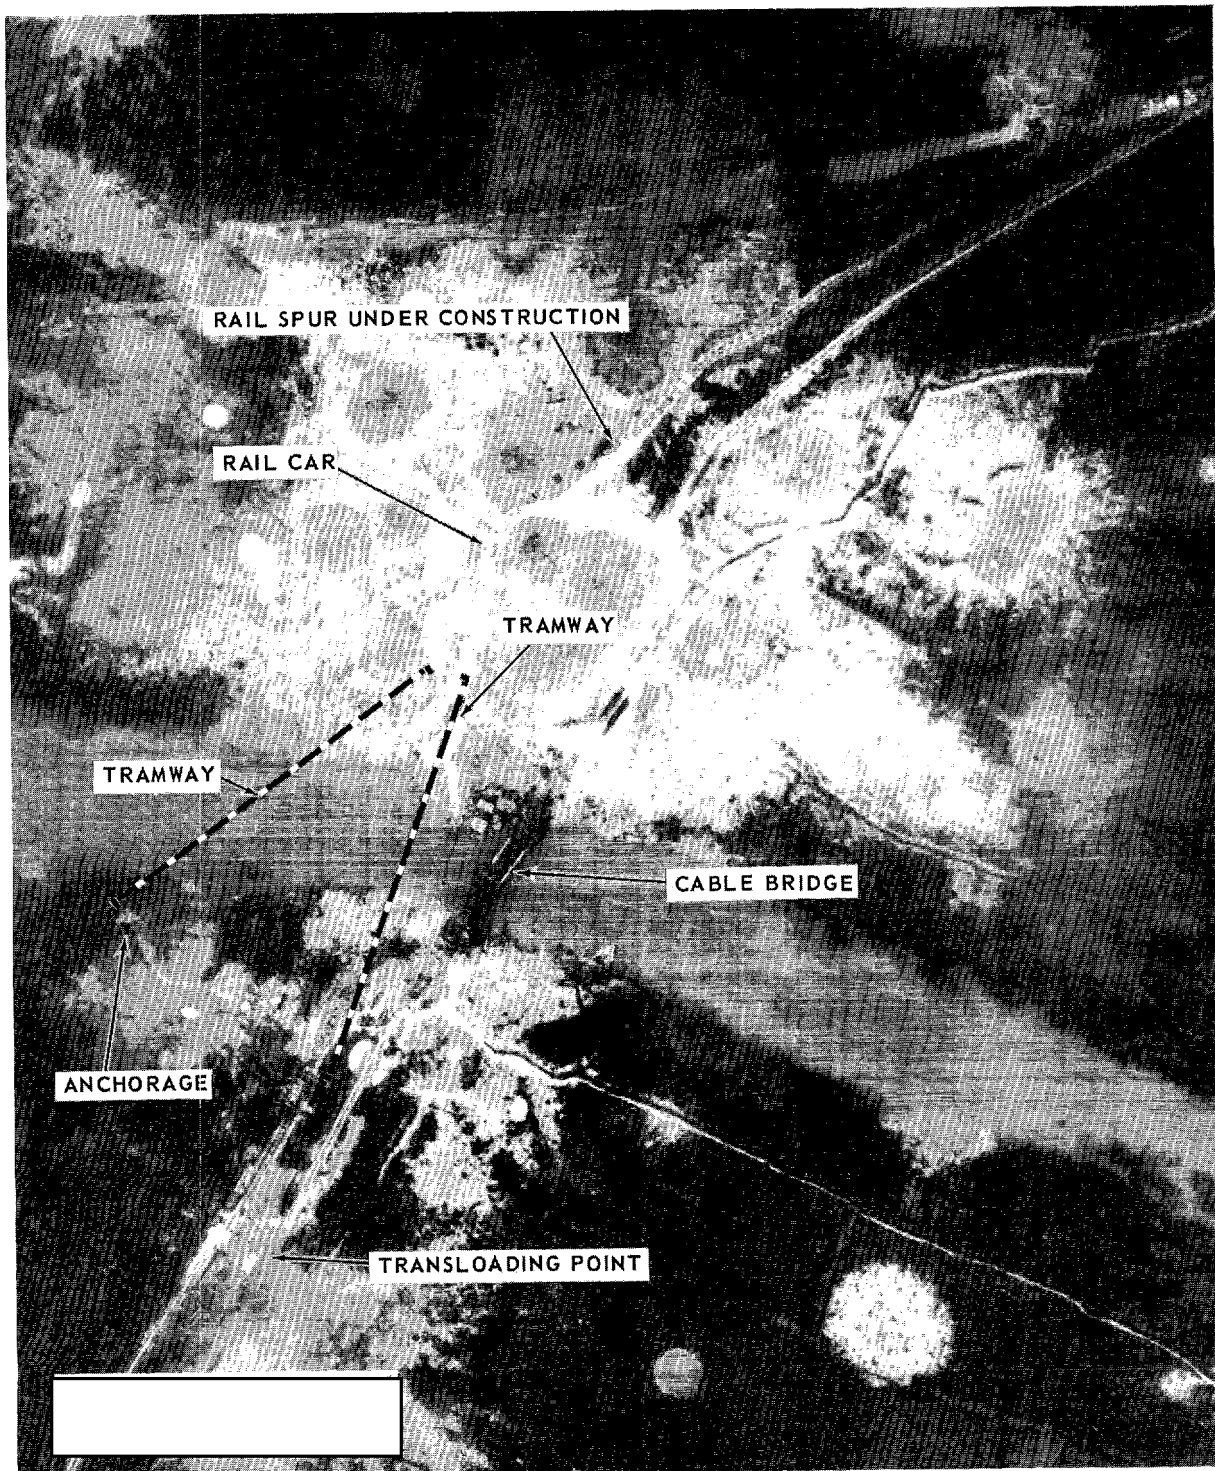
NPIC L-5577 (9/66)

Reconstruction of the severely damaged cable bridge at the destroyed Xom Khe Railroad Bridge over the Khe Net [REDACTED] at UTM WE987877 was complete on [REDACTED] and it is now serviceable for transloading operations (Figure 13). Construction of a new rail spur northeast of the bridge from the main line to the vicinity of two tramways indicates that the tramways, previously thought limited to a construction function, will probably augment transloading operations at the cable bridge. A possible specially constructed rail car was observed on the spur. Construction has been abandoned on the previously reported by-pass.

FIGURE 13. RAILROAD CABLE BRIDGE, VINH/DONG HOI RAIL LINE, NORTH VIETNAM.

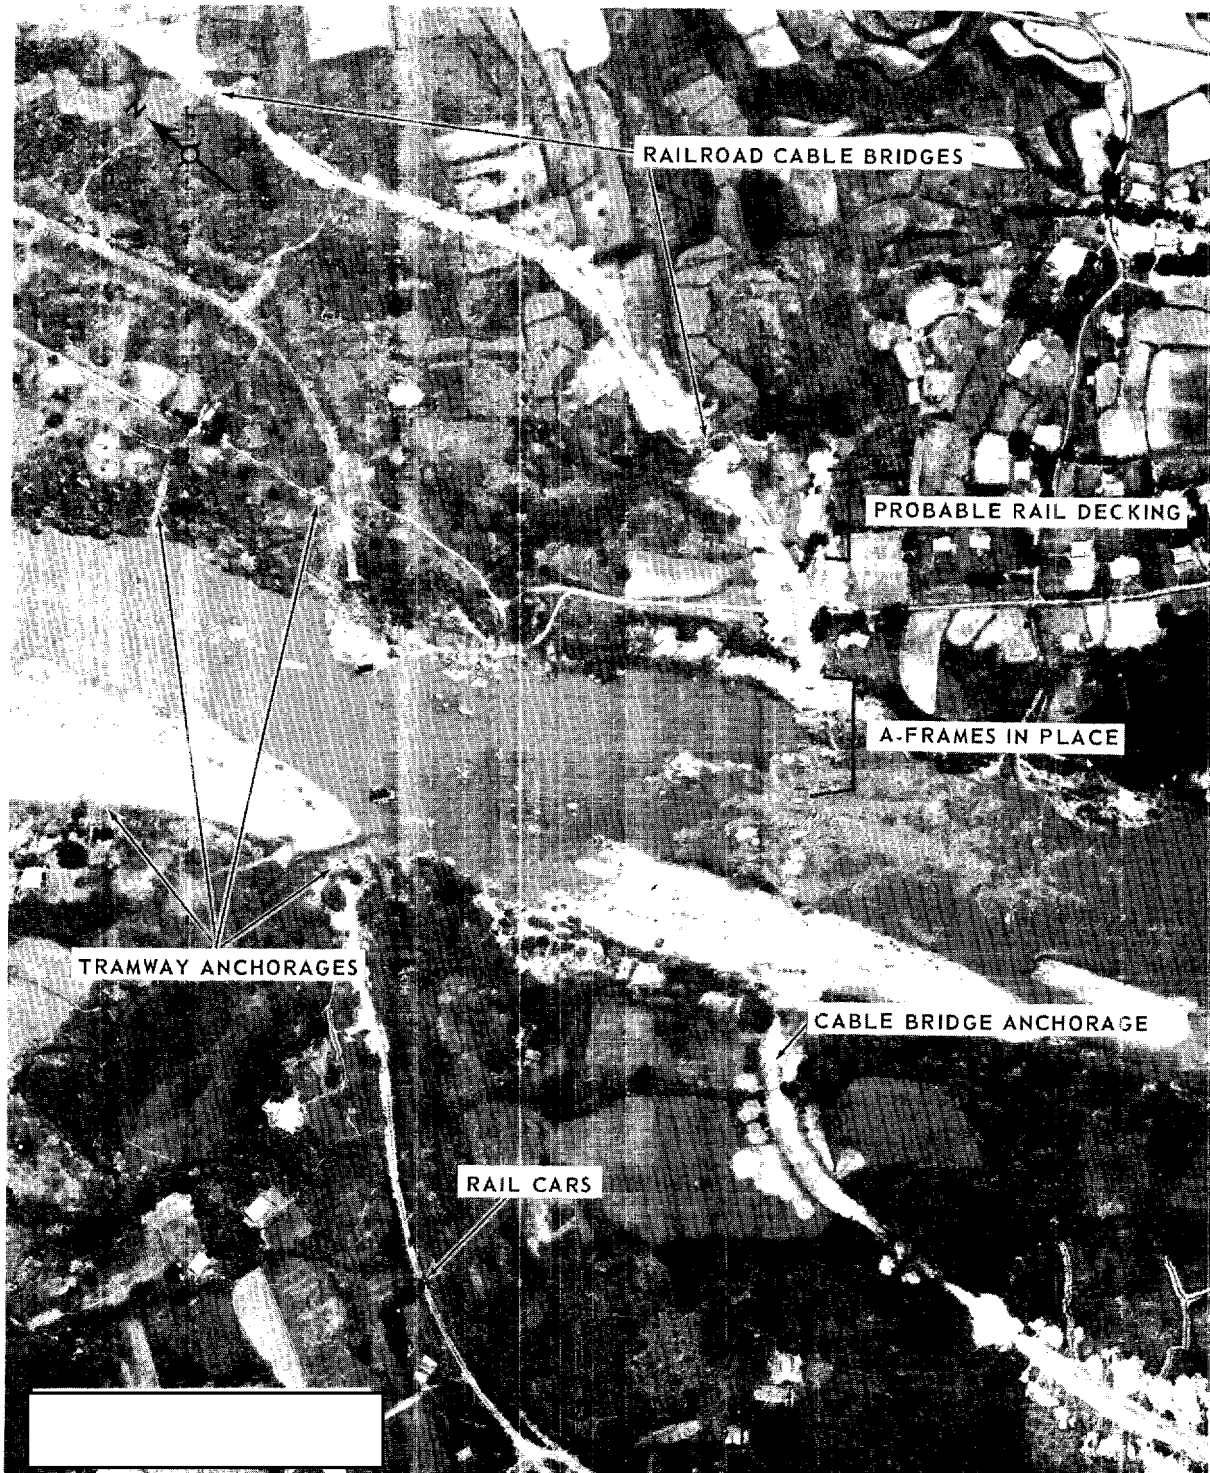
NPIC L-5578 (9/66)

The major natural obstacle to the progress of the rail line reconstruction between the new transshipment point and Dong Hoi is the Rao Nay (river) in the vicinity of Thuong Phong Trang. Construction of a railroad cable bridge southeast of the destroyed Thuong Phong Trang Railroad Bridge over the Rao Nay [REDACTED] at UTM XE064801 was first observed on photography of [REDACTED] (Summary 15). Six A-frames were in place on [REDACTED] (Summary 17). Although no additional supports had been erected by [REDACTED] (Figure 14), this does not accurately reflect the current construction status. Cables are taut, foundations for the remaining A-frames are positioned, and a par-

tially concealed probable rail decking is in line with the bridge on the north bank. Relatively little effort is required to erect the remaining A-frames and to position the decking. Completion of the bridge therefore probably depends on completion of the by-pass approaches. Two small cable bridges have been constructed on the northern by-pass, but track has not been laid. Three operational tramways (two shown in Figure 14) served by the main line are located northwest of the destroyed Thuong Phong Trang bridge. Two small rail cars are partially concealed on the main line south of the tramways. There has been no significant change in the status of the additional probable railroad cable bridge under construction at UTM XE075798 since it was reported in Summary 19.

FIGURE 14. RAILROAD CABLE BRIDGE UNDER CONSTRUCTION AND ASSOCIATED ACTIVITY, VINH/DONG HOI RAIL LINE, NORTH VIETNAM.
